Grading capacitors for circuit breakers

Service experience and failure mechanisms

Contribution from Cigré WG A3.18 (M. Runde, A. Bosma, P. Coventry, S. Dick, P. Gramaglia, H. Jahn, N. Koch, E. Kynast, M. Predovan, A. Ribeiro, E. Savary, B. R. Sunga, D. Yoshida)

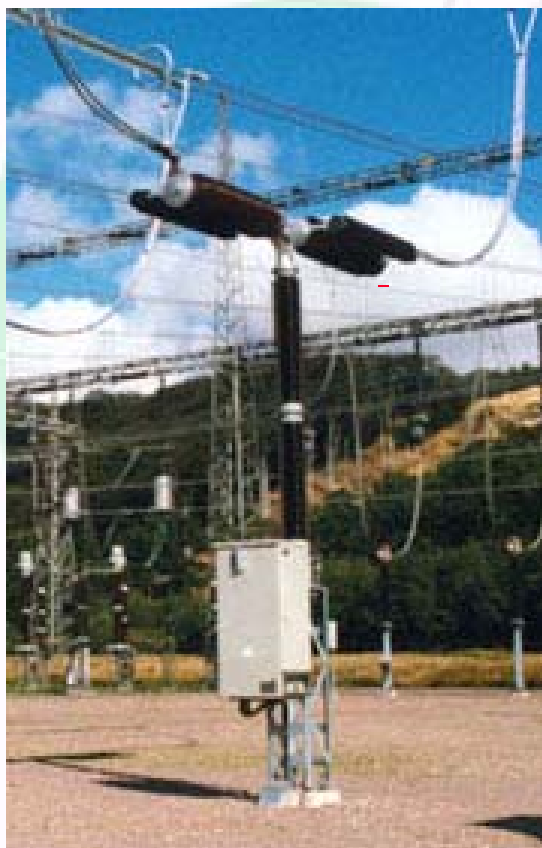
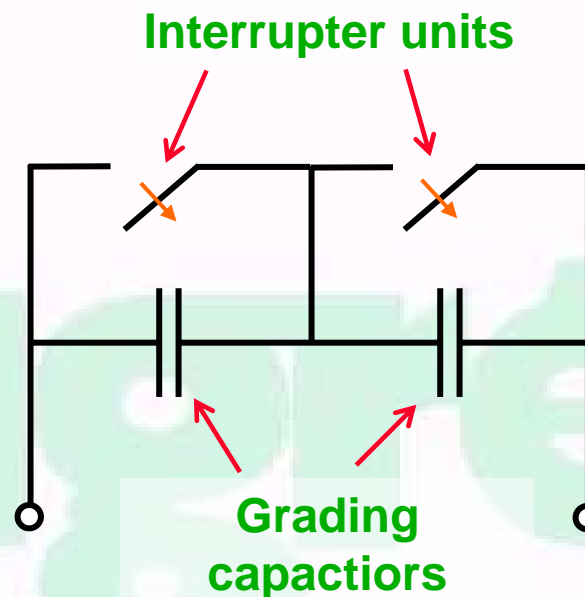
Grading capacitors control the voltage distribution in multi-unit circuit breakers

Capacitive voltage division equalizes the dielectric stress both in open position and during switching

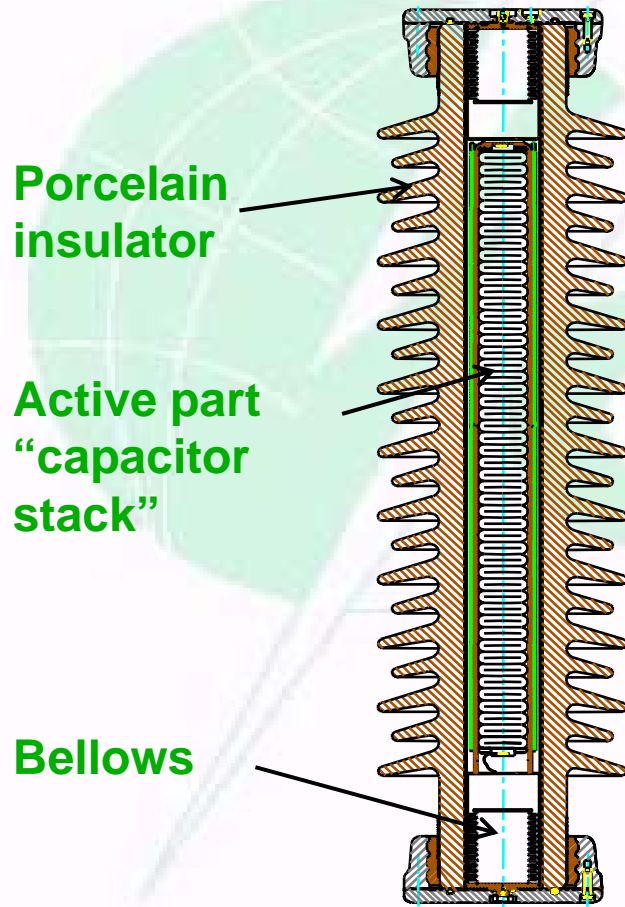
A stack of capacitor elements made of foils is placed inside a hollow insulator

- Paper or polypropylene or "mixed" dielectric with metal film electrodes
- Foils of dielectric and metal are wound on a mandrel and flattened
- 100 - 200 capacitor elements connected in series
- Impregnated / insulated with oil, or sometimes SF₆

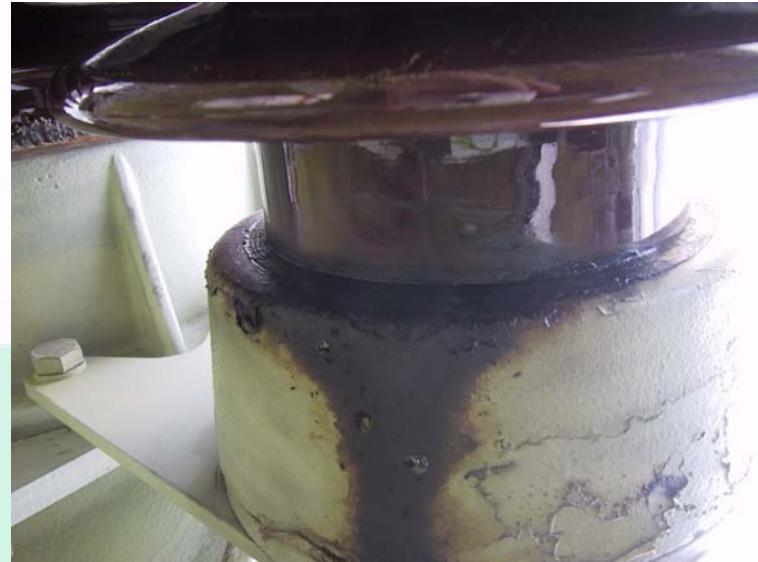
Leak is the most common problem type

- Oil leaking out (both AIS and GIS)
- SF₆ leaking in (in GIS)
- Moisture ingress (in AIS)

- Predominantly on old (> 20 years) units
- Very common; one utility reported replacement of 5.000 or 20 % of their grading capacitors
- In some GIS the majority of the grading capacitors leaked

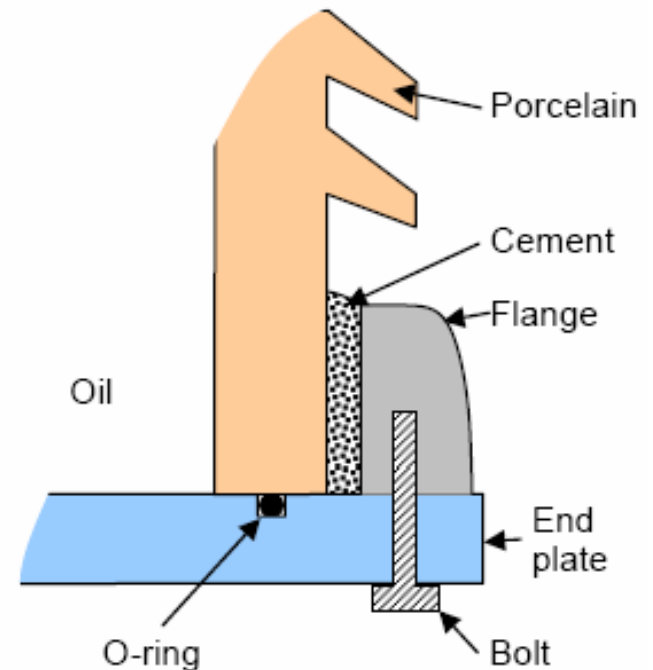
Leaks are predominantly an insulator / housing problem

- **Crevice corrosion at flange - end plate interface**
- **Pitting corrosion in o-ring groove**
- **Cracking of cement**
- **For GIS capacitors: Poor workmanship during capacitor assembly**

- **A few cases of disruptive failures**
- **Replacement of grading capacitors**
- **Just a few utilities reported repairing capacitors**

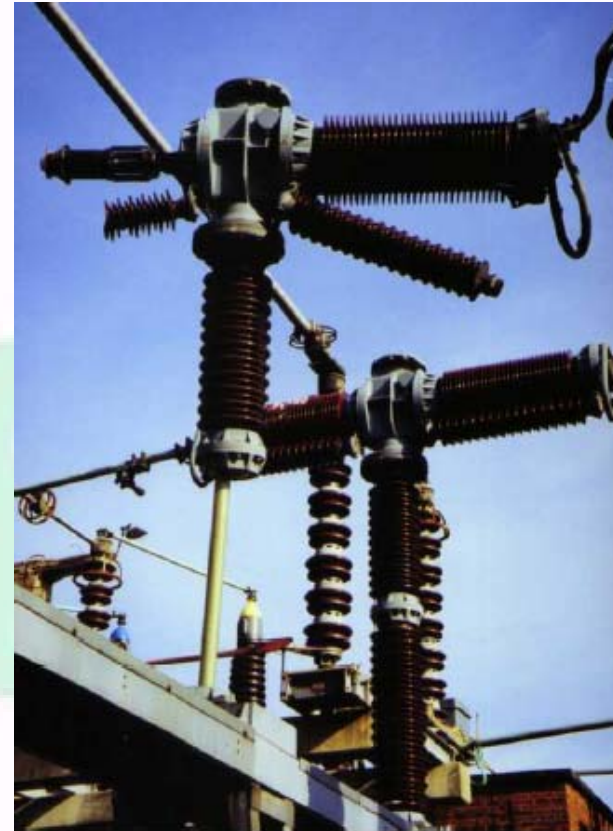
A few dozens of disruptive dielectric breakdowns were reported

- **Dielectric breakdown in capacitor**
- **Usually a very violent incident**

- **Not very common; a few dozens cases only**
- **Both in AIS and GIS**
- **In most cases on reactor breakers**
- **Occurs after opening operation**

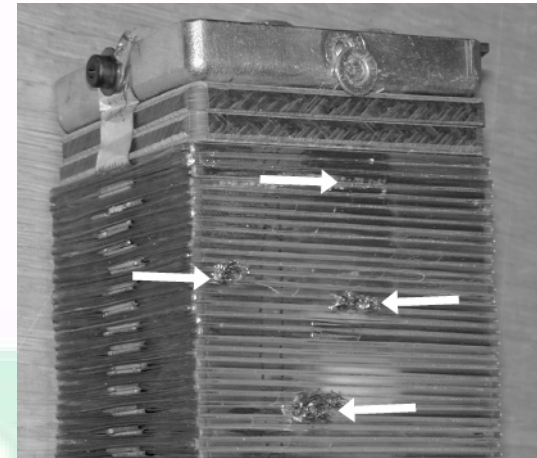
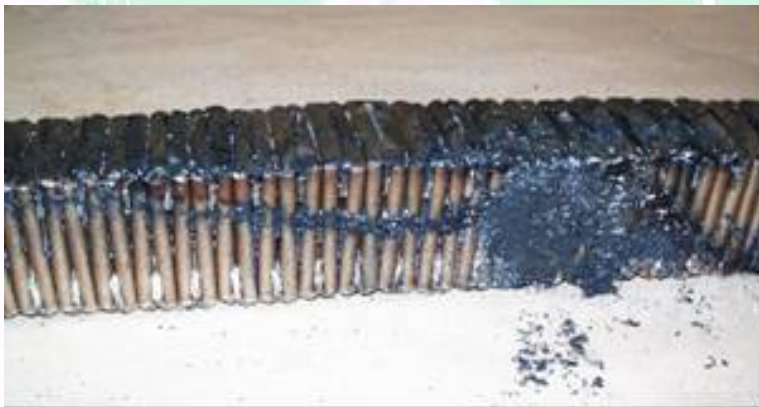
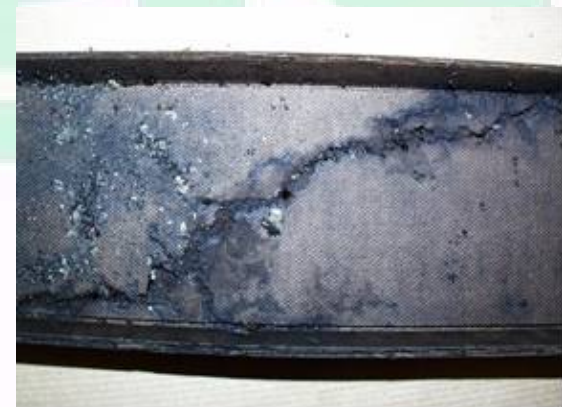
Apparently some very large overvoltages may occur during reactor switching

- The dielectric stress during reactor switching appears in some cases to exceed the strength of the capacitor elements
- Hence, internal breakdowns occur

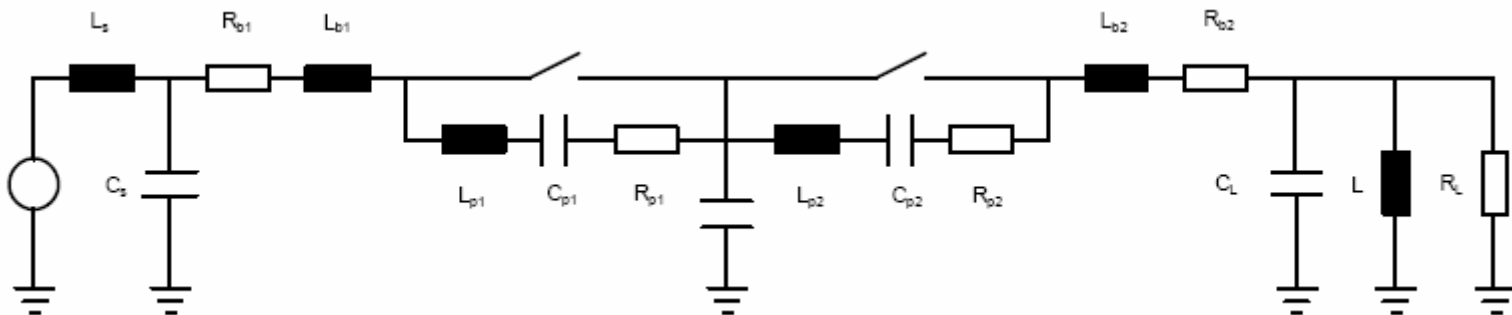
The origin/cause of the dielectric failures have not been understood

- Simulations and measurements have not been able to explain the phenomenon
- Modeling these phenomena is by no means straightforward, but we are working on it
- What happens inside the first parallel circuit remains the crucial and elusive question.
- Uneven voltage sharing between the grading capacitors may play an important role

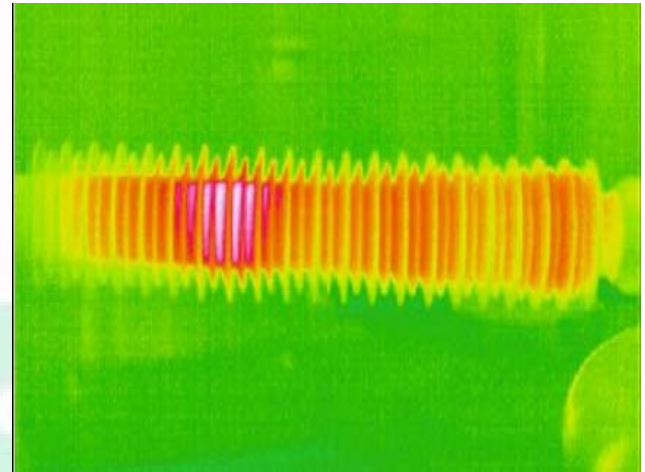
As long as the cause of the dielectric failures is elusive, it is difficult to prescribe countermeasures

- **Some utilities have installed controlled switching units to eliminate re-ignitions and thereby try to avoid these failures**
- **However, at least one reactor breaker with controlled switching has also experienced dielectric failure**
- **Infrared imaging surveillance may reveal internal failures, but at a very late stage**

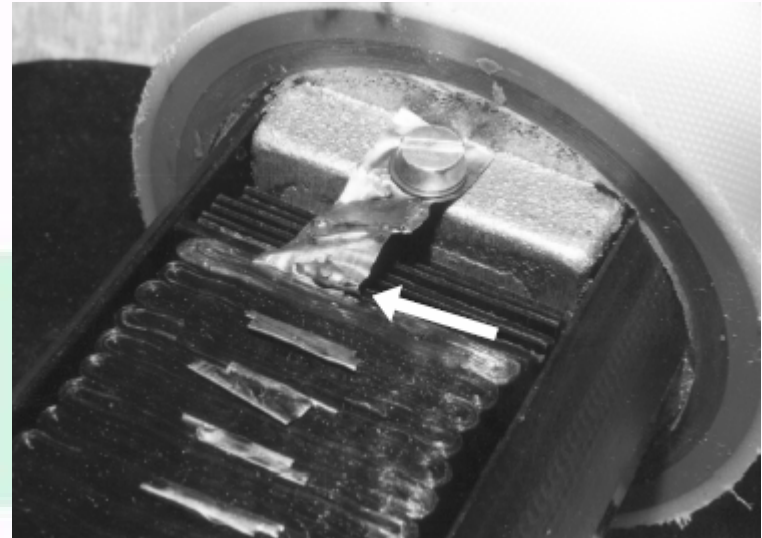
Some cases of damaged internal conductors were reported

- **Metal foil conductors connecting capacitor elements break off**
- **Open circuit causes arcing and fast deterioration**
- **Indications of mechanical fatigue have been found**

- **Several cases found on a few rather old capacitor designs**

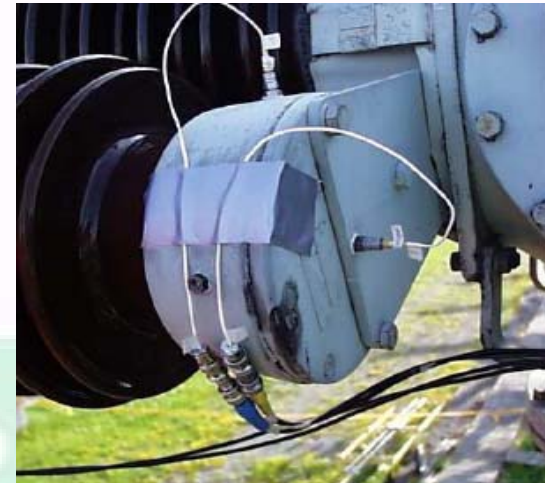
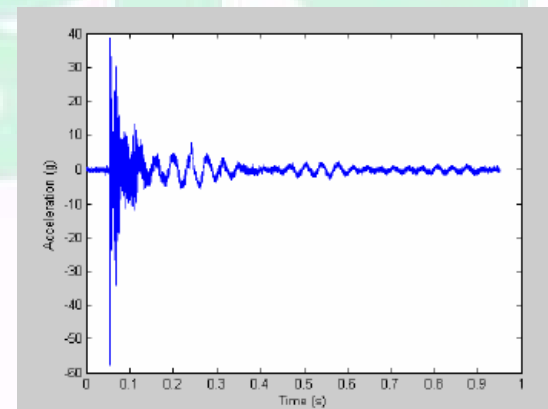
Circuit breaker operations stress the grading capacitors mechanically

- **Circuit breaker operation introduces mechanical shocks and vibrations**
- **In some old and poor designs these stresses appear to have caused the damage**

- **Newer designs appear to be much more mechanically robust, and virtually no problems have been reported**
