Cigre WG A3-06 “HV Equipment Reliability”

Preliminary Results from Present Cigre Survey

Gas Insulated Substations (GIS)

WG A3-06 Tutorial

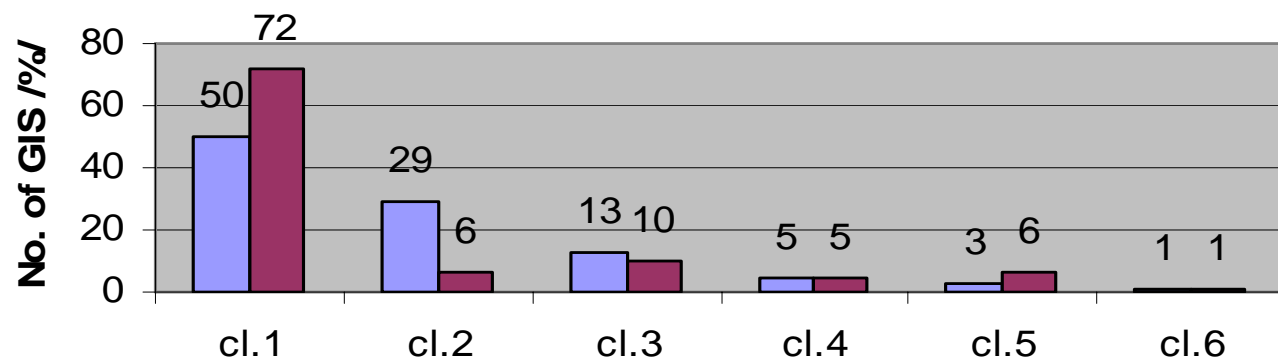
1995 & New Survey - No. of GIS x U class

355% of GIS No.in 1995

Blue : 1995 Survey
Red : New Survey

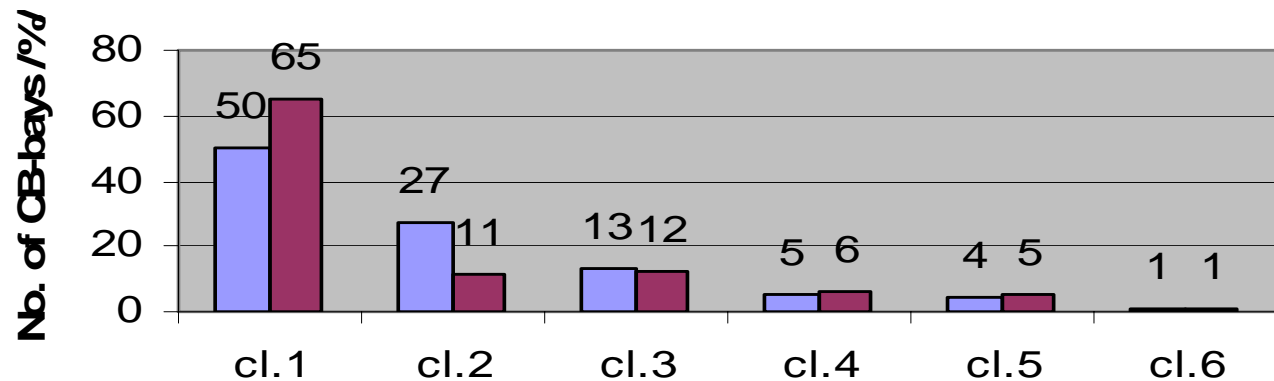
111% of GIS CB-bays in 1995

1995 & New Surveys - No. of GIS CB-bays x U class

Cl. 1 : ≥ 60 ... < 100 kV
Cl. 2 : ≥ 100 ... < 200 kV
Cl. 3 : ≥ 200 ... < 300 kV
Cl. 4 : ≥ 300 ... < 500 kV
Cl. 5 : ≥ 500 ... < 700 kV
Cl. 6 : ≥ 700 kV

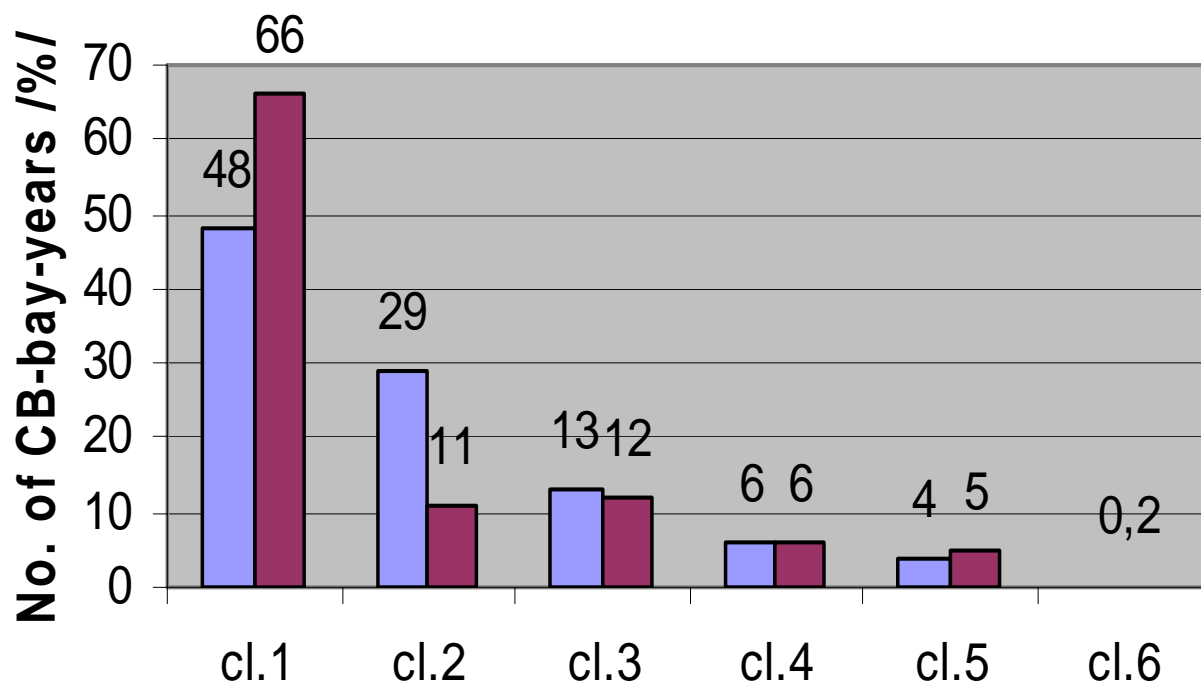
1995 & New Surveys - No. of GIS CB-bay-years x U class

176% of GIS CB-bay-years No. in 1995

Blue : 1995 Survey

Red : New Survey

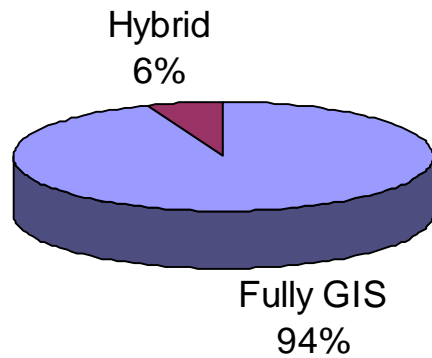
1995 Survey - GIS part extent

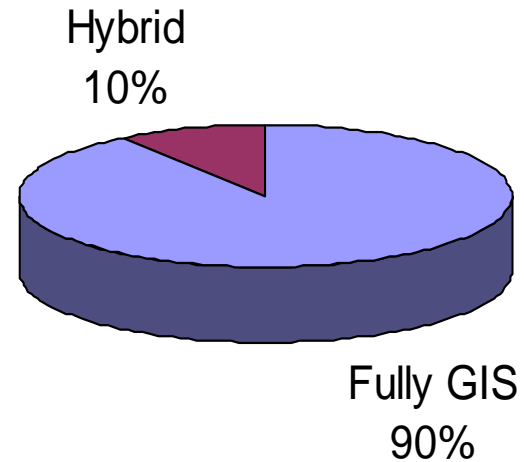
New Survey - GIS part extent

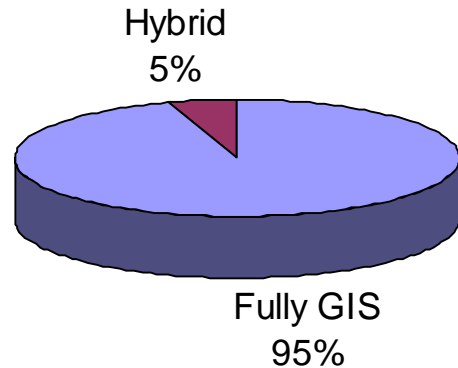
1995 Survey - CB-bays GIS part extent

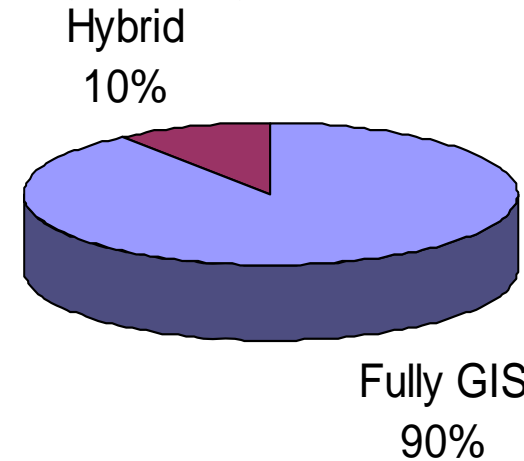
New Survey - CB-bays GIS part extent

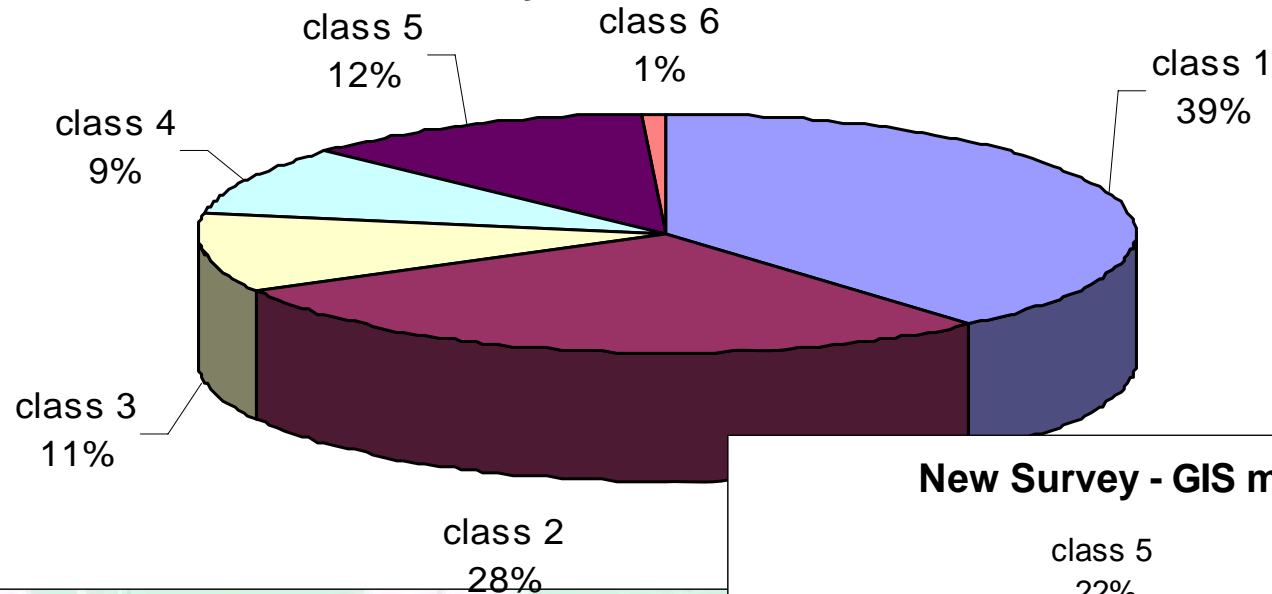
New Survey - GIS failures x U class

- Class 1 : $\geq 60 \dots < 100$ kV**
- Class 2 : $\geq 100 \dots < 200$ kV**
- Class 3 : $\geq 200 \dots < 300$ kV**
- Class 4 : $\geq 300 \dots < 500$ kV**
- Class 5 : $\geq 500 \dots < 700$ kV**
- Class 6 : ≥ 700 kV**

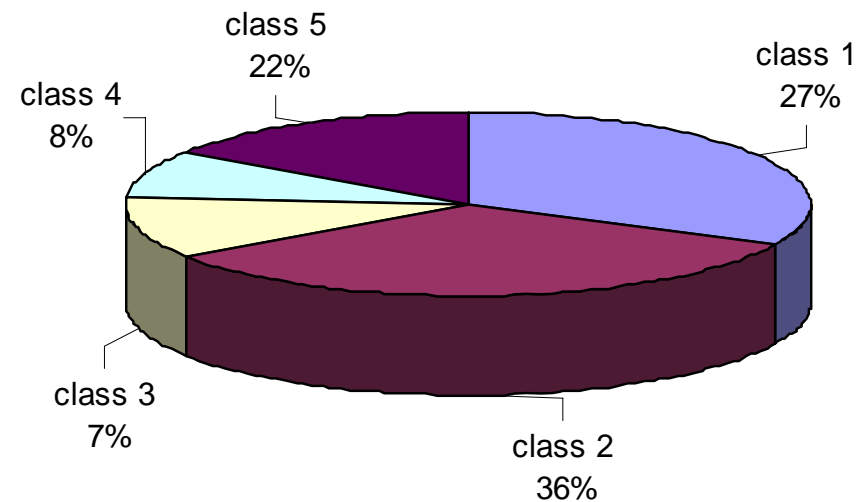
New Survey - GIS minor failures x U class

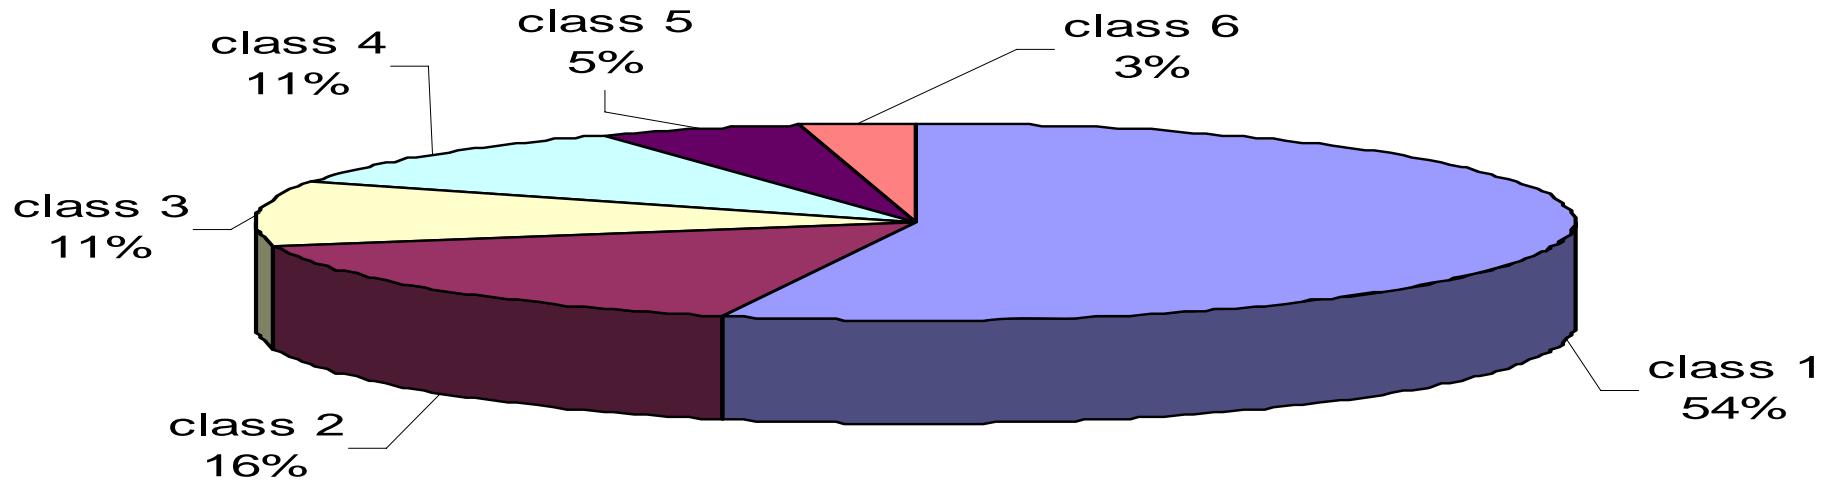
New Survey - GIS major failures x U class

NEW SURVEY : 20% of major failures number in 1995 survey

- Class 1 : $\geq 60 \dots < 100$ kV**
- Class 2 : $\geq 100 \dots < 200$ kV**
- Class 3 : $\geq 200 \dots < 300$ kV**
- Class 4 : $\geq 300 \dots < 500$ kV**
- Class 5 : $\geq 500 \dots < 700$ kV**
- Class 6 : ≥ 700 kV**

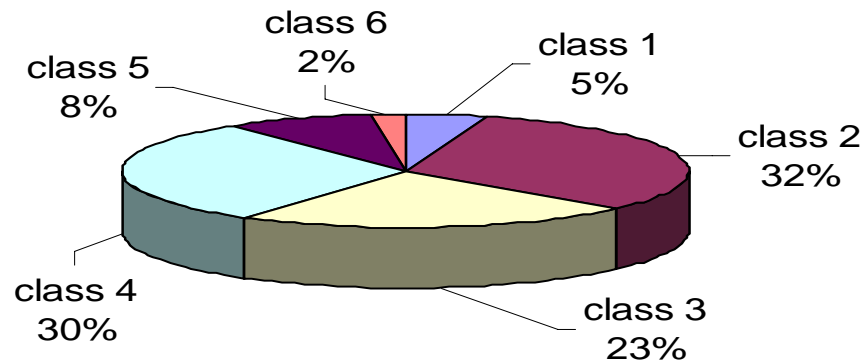
1995 Survey - GIS major F x U class

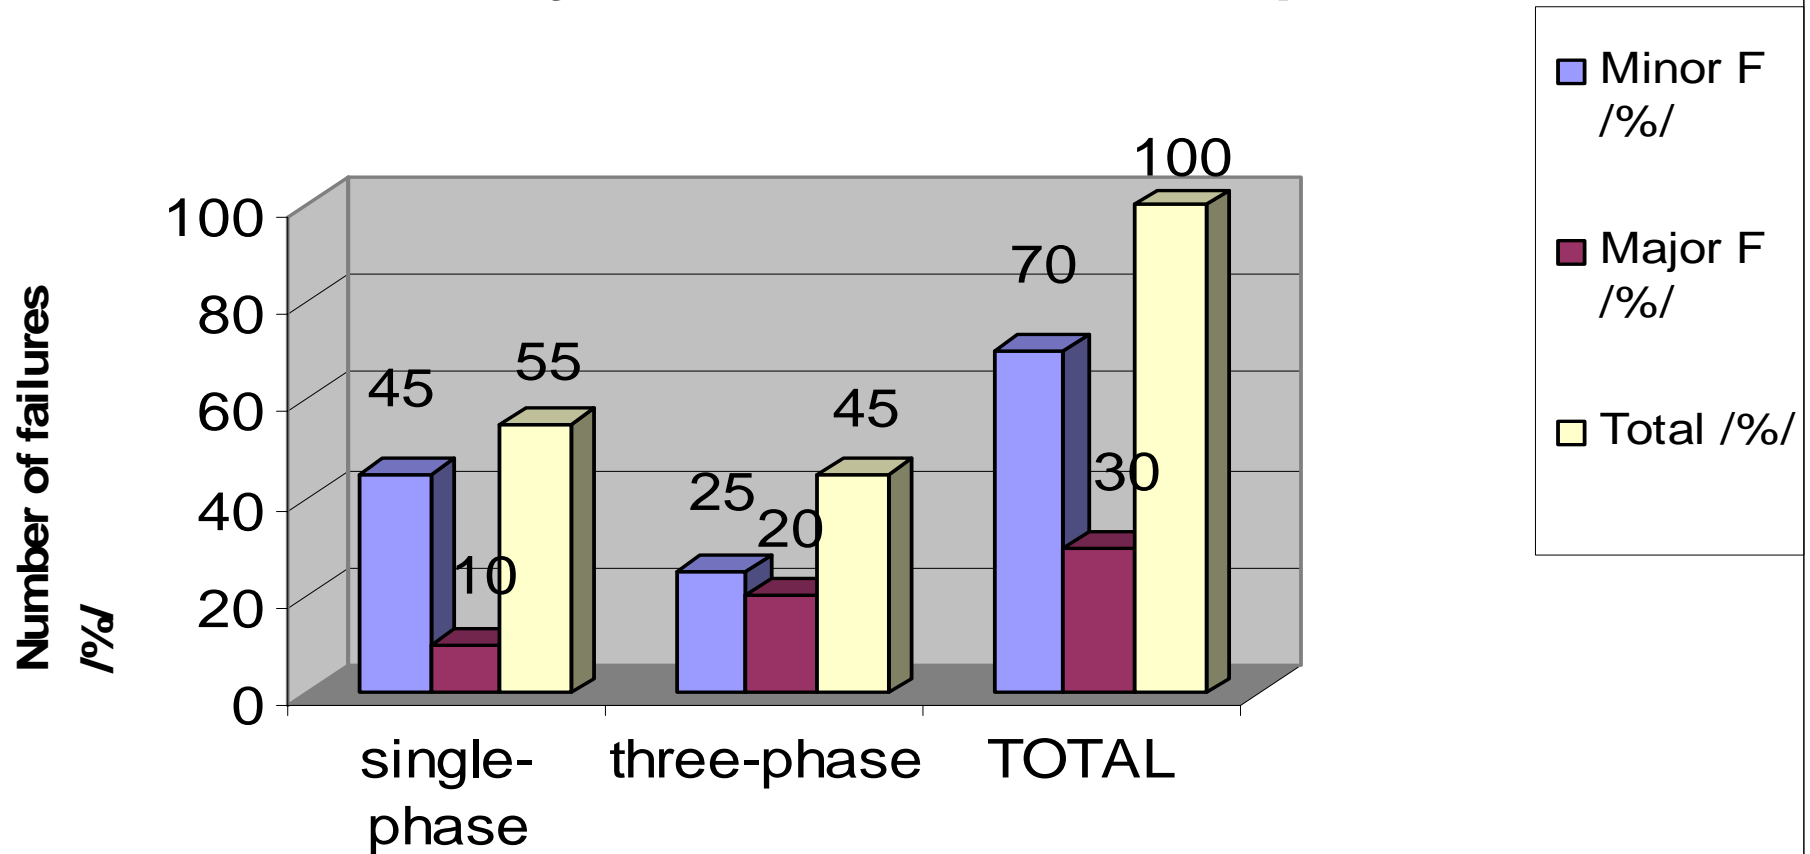
New Survey - GIS failures x Encapsulation

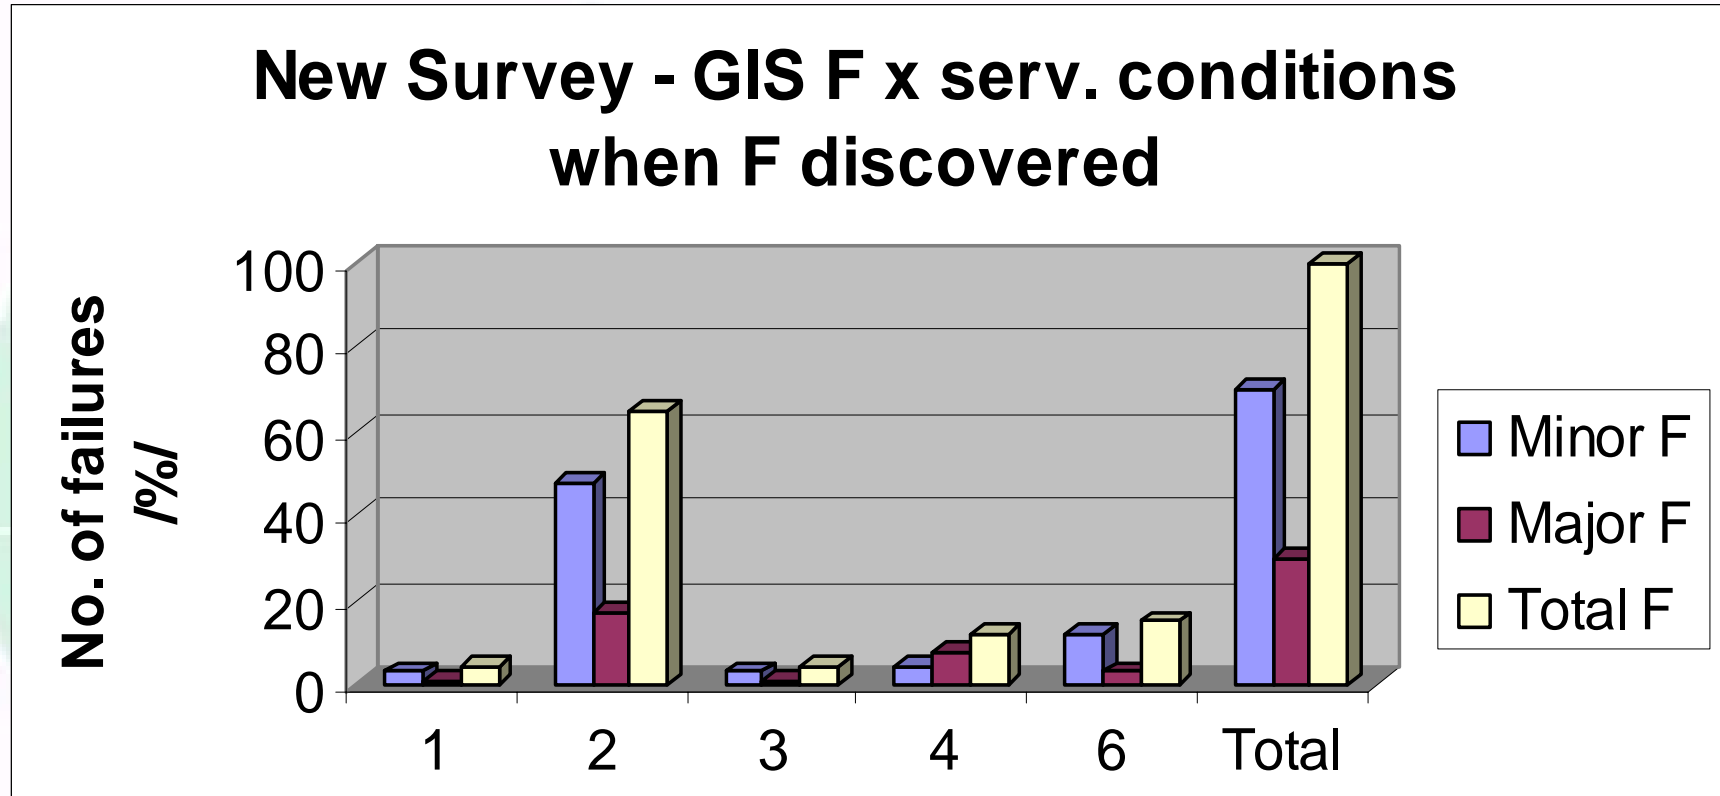
1 -De-energized - available for service

2 -Normal service - no operation command in S/S

3 -During normal operation in S/S

4 -During normal switching operation (CB,DS,ES)

6 -During testing/maintenance

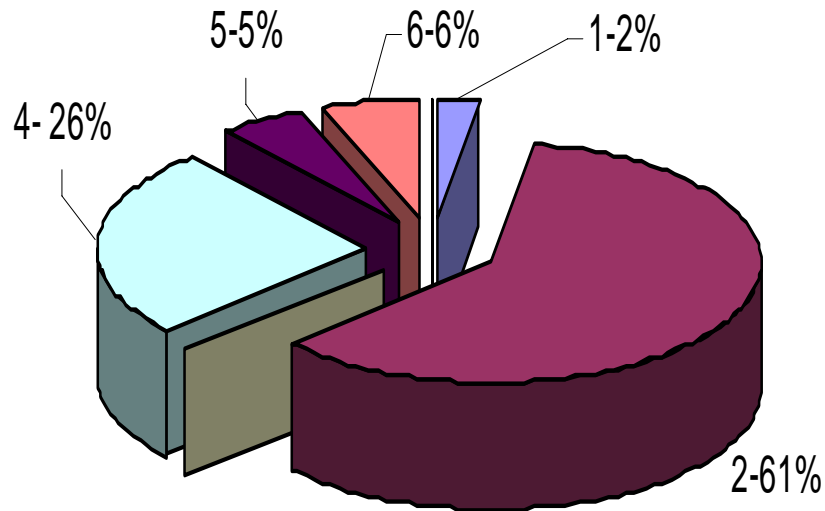
1995 Survey - Major F x conditions when F discovered

- 1 -De-energized - available for service
- 3 -During normal operation in S/S
- 5 -Fault clearing operation
- 7 -During misoperation in S/S

- 2 -Normal service - no operation command in S/S
- 4 -During normal switching operation (CB,DS,ES)
- 6 -During testing/maintenance

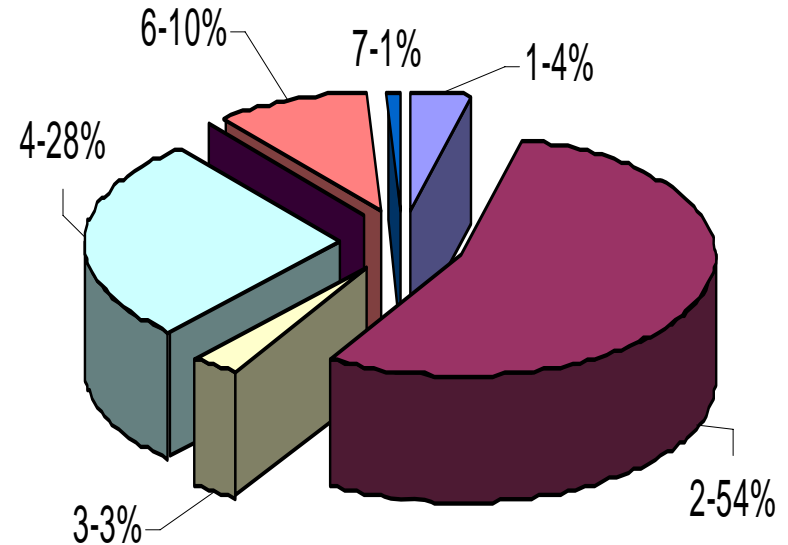
New Survey - Major F x conditions when F discovered

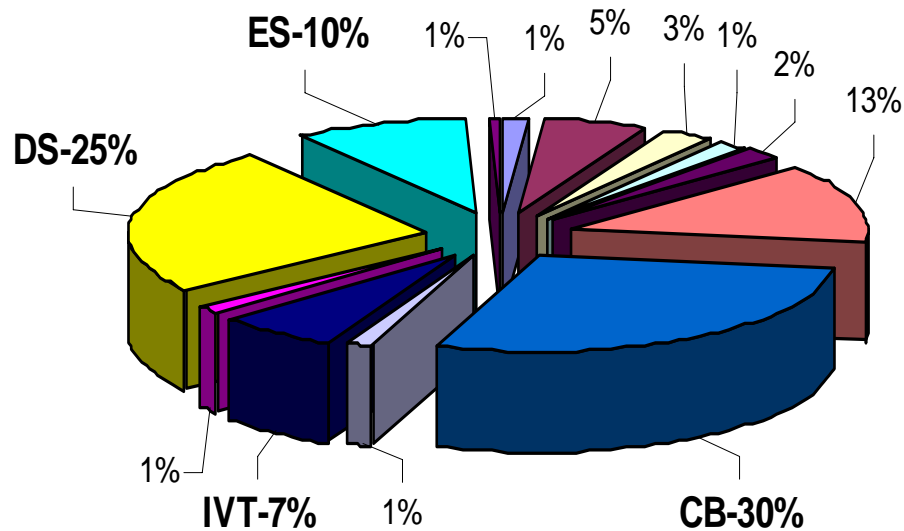
New Survey - Failures x GIS component

- Busduct
- Busbar
- SF6/air bush.
- Cable box
- T chamber
- Other
- CB
- CS/LB
- IVT
- CT
- DS
- ES
- CDES

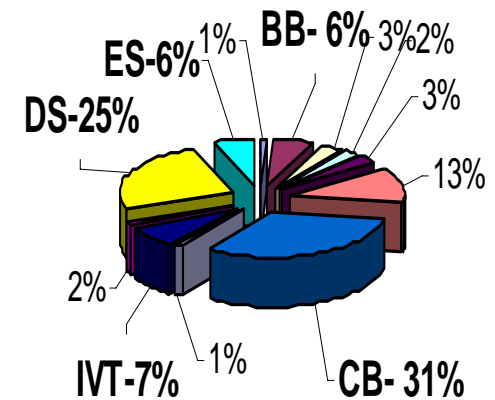
New Survey - Minor F x GIS component

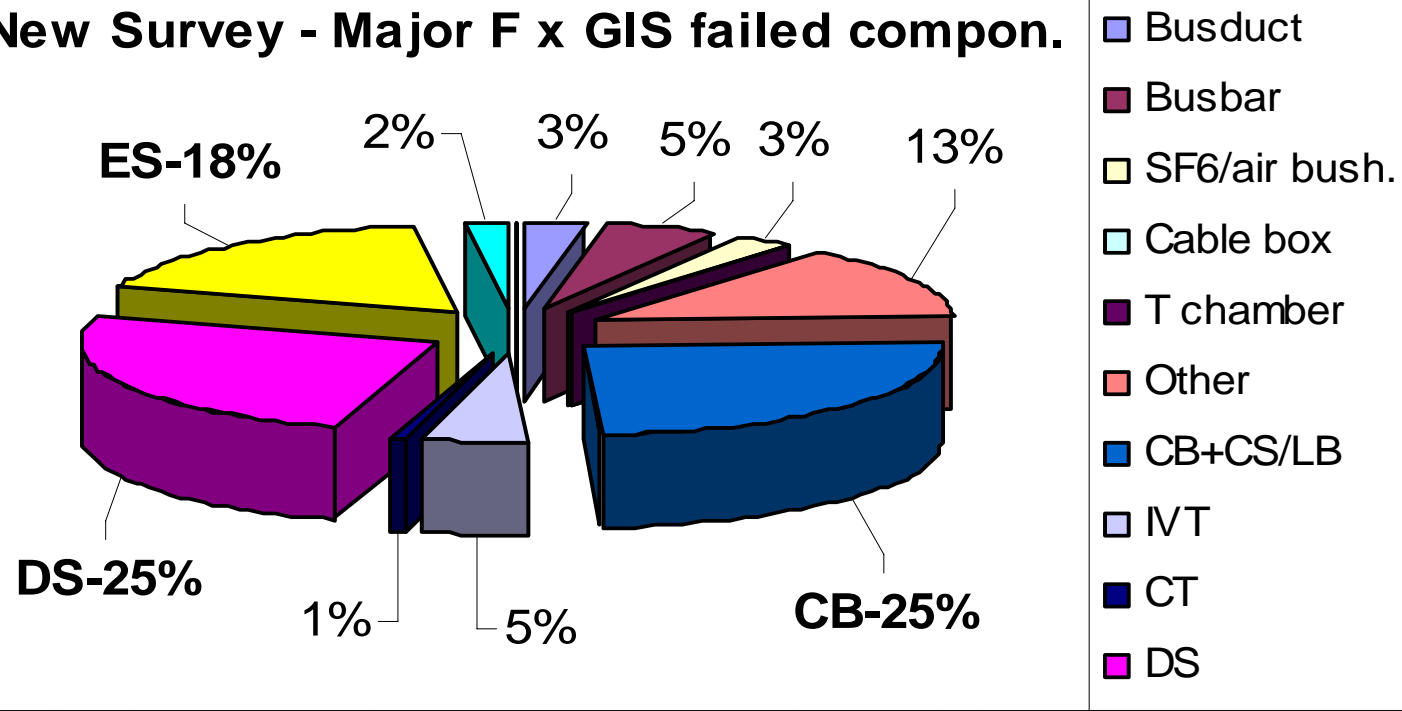
New Survey - Major F x GIS failed compon.

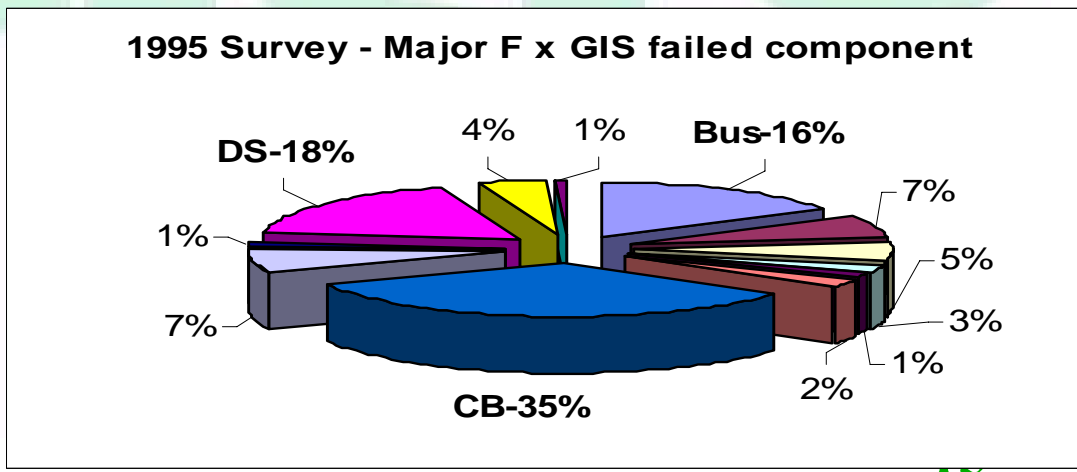
1995 Survey - Major F x GIS failed component

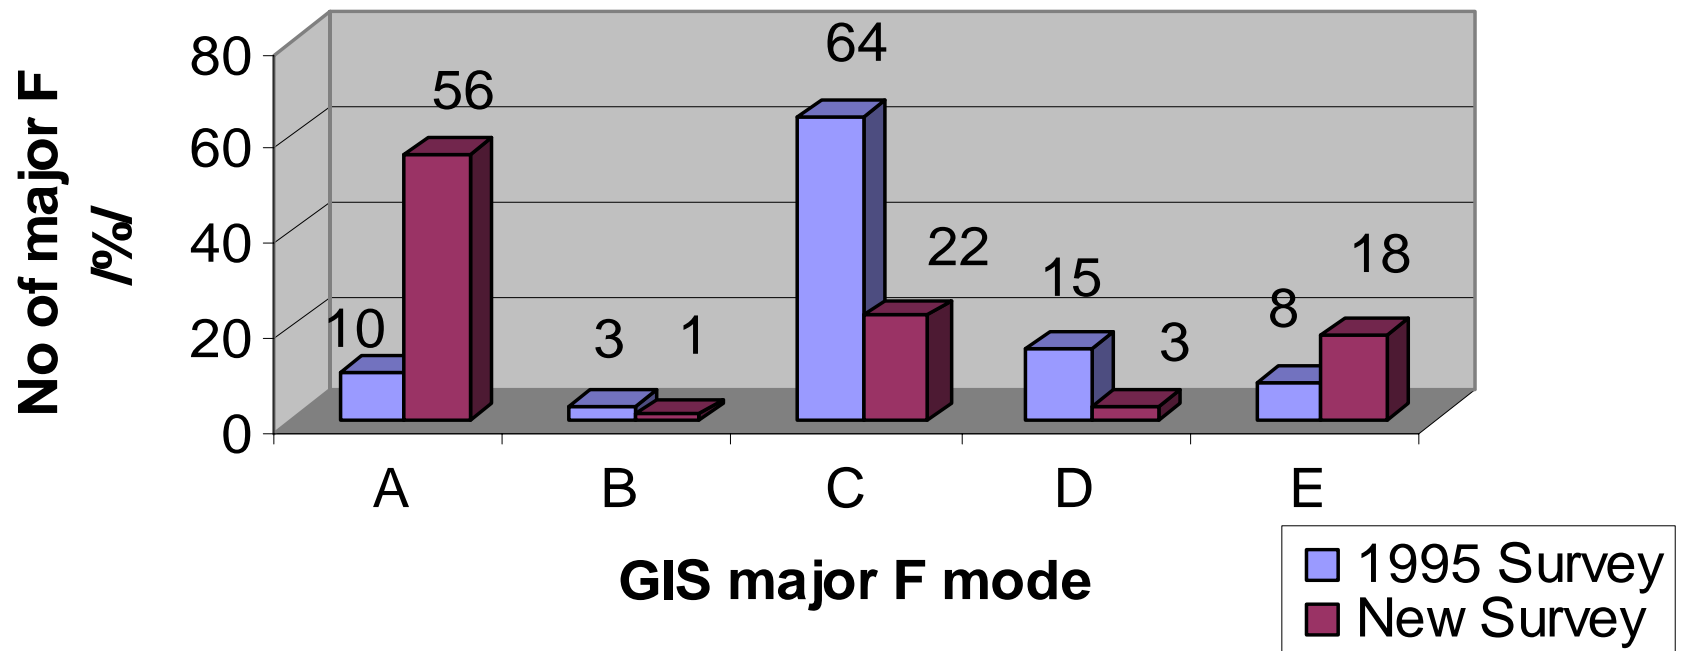
1995 & New Surveys - GIS major F modes

A - Failing to perform requested operation or function resp.

B - Loss of electrical connections integrity

C - Dielectric breakdown

D - Loss of mechanical integrity (big SF6 leakage incl.)

E- Other

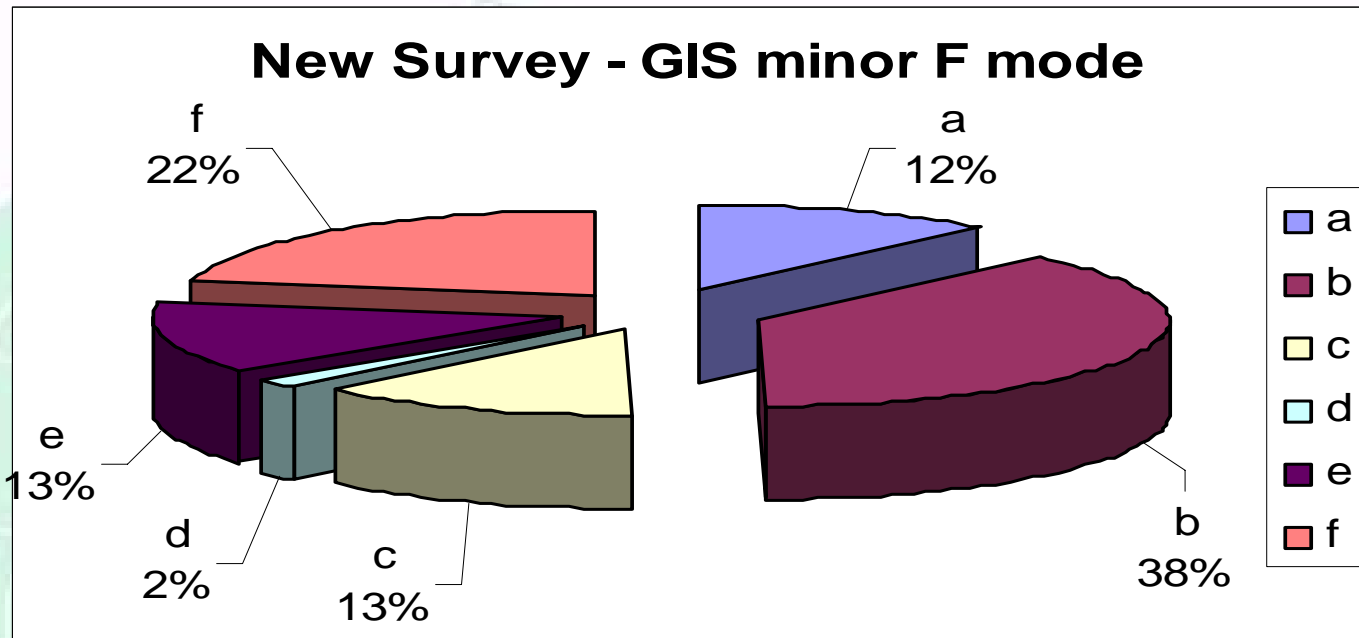
a - Mechanical weakness in operating mechanism

b - Small SF6 leakage

c - Mechanical weakness in primary

d - Electrical or dielectrical weakness in primary

e - Mechanical or electrical weakness in control, auxiliary and monitoring

f - Other

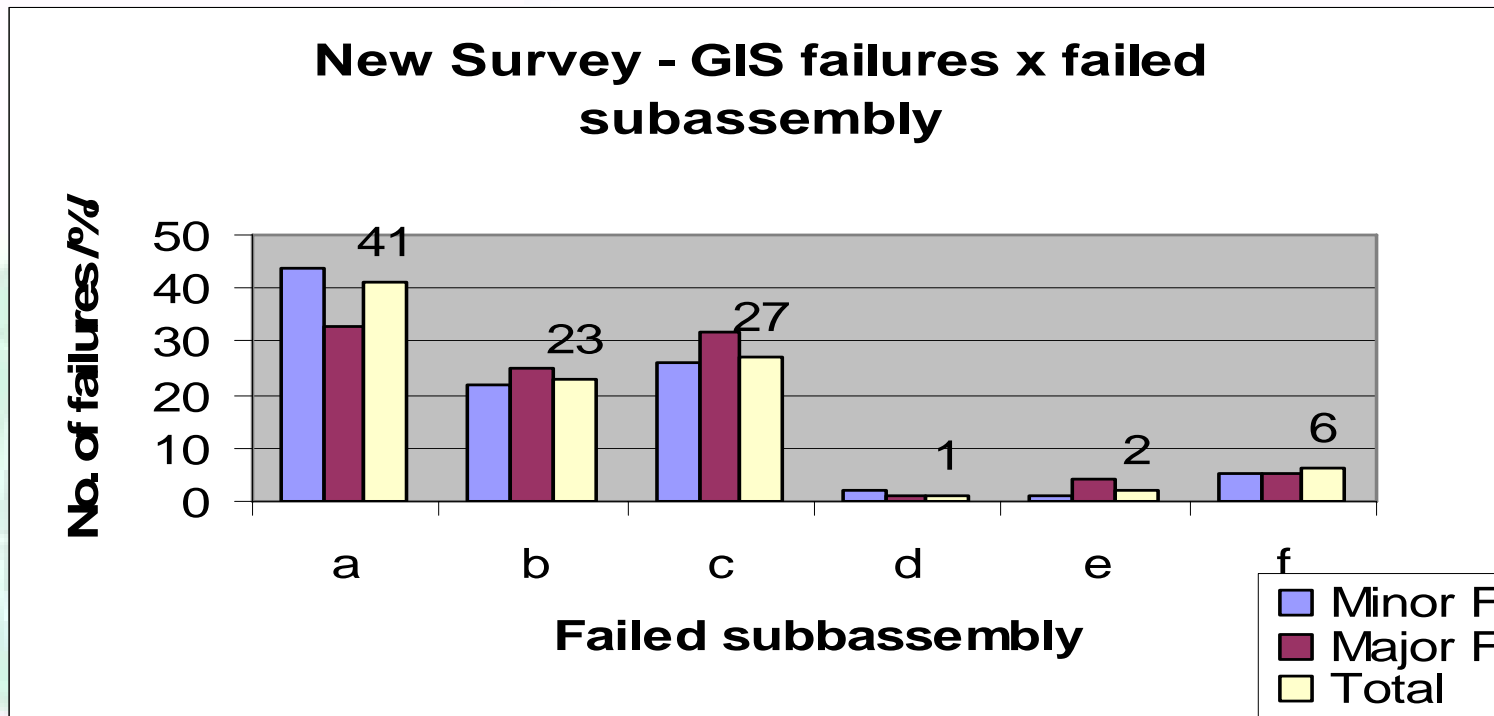
a - Component in primary circuit

b - Component in control, auxiliary or monitoring circuit

c - Component in operating mechanism

d - Component in kinematic chain

e - Component in IT secondary circuit

f - Unknown or other

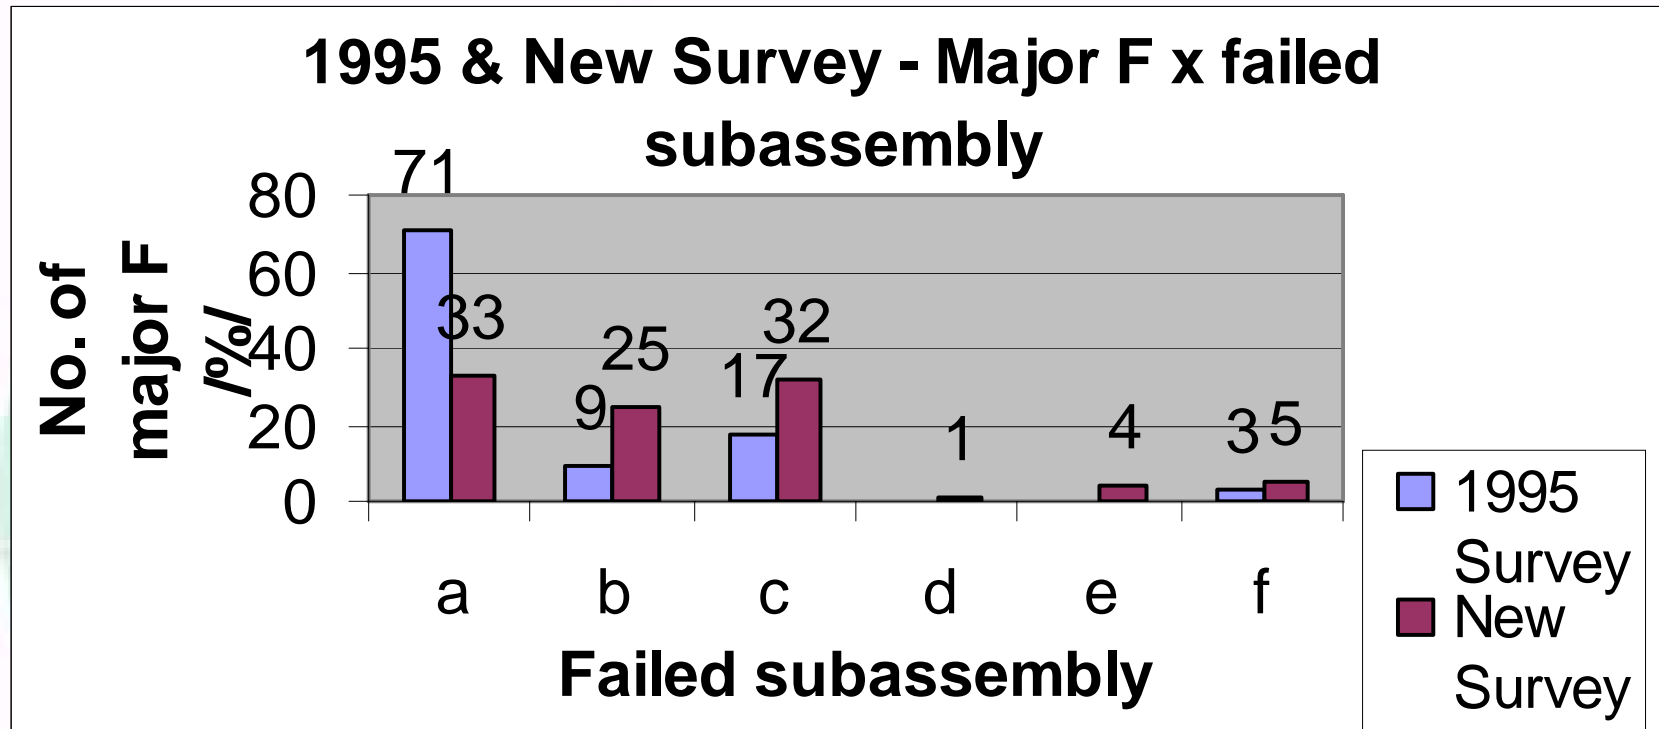
a - Component in primary circuit

b - Component in control, auxiliary or monitoring circuit

c - Component in operating mechanism

d - Component in kinematic chain

e - Component in IT secondary circuit

f - Unknown or other

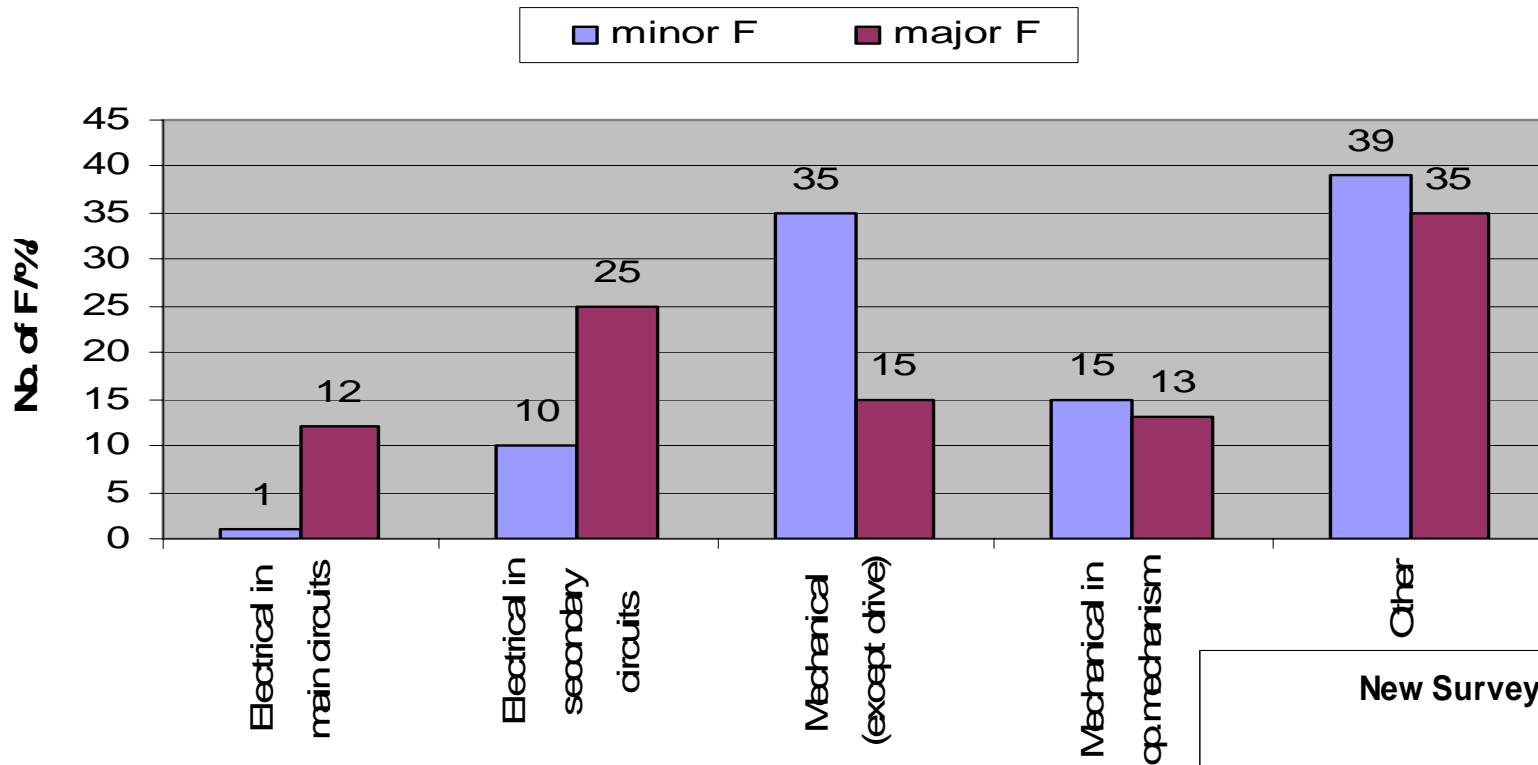
New Survey - Minor & Major F x origin

A - Cause introduced during a period before putting into service

- a - Design fault (manufacturer responsibility)
- b - Engineering fault (utility responsibility)
- c - Manufacturing fault (poor quality control)
- d - Incorrect transport or erection
- e - Inadequate instructions for transport, erection, operation
- f - Other before PTS

B - Cause introduced during service

- h - Current in excess of rating
- i - Voltage at power frequency in excess of rating
- j - Switching overvoltage in excess of rating
- k - Lightning overvoltage in excess of rating
- l - Mechanical stress in excess of rating
- m - Environmental stresses (other than lightning)
- n - Corrosion
- o - Wear / Ageing
- p - Incorrect operation
- q - Incorrect monitoring
- r - Electrical failure of adjacent equipment
- s - Mechanical failure of adjacent equipment
- t - Human error
- u - Incorrect maintenance (incl. instruction)
- v - External damage caused by animals, humans etc.
- w - Other abnormal service conditions

C - Unknown other causes

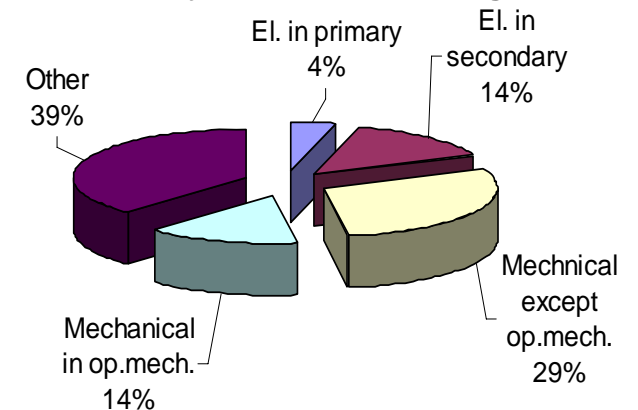
New Survey - GIS failures x origin

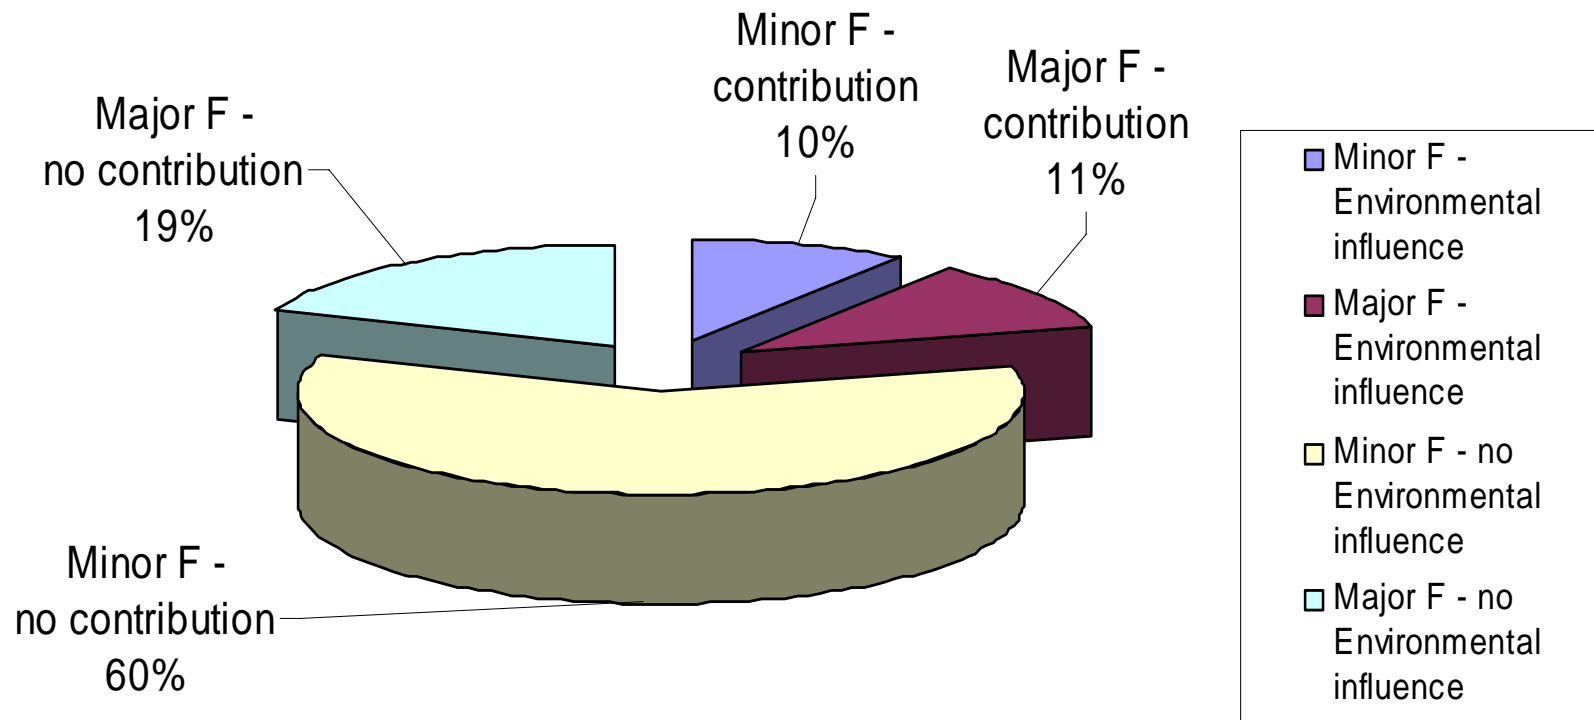
GIS failures versus environmental contribution

Outdoor GIS failures represent 87 % of failures influenced by environment

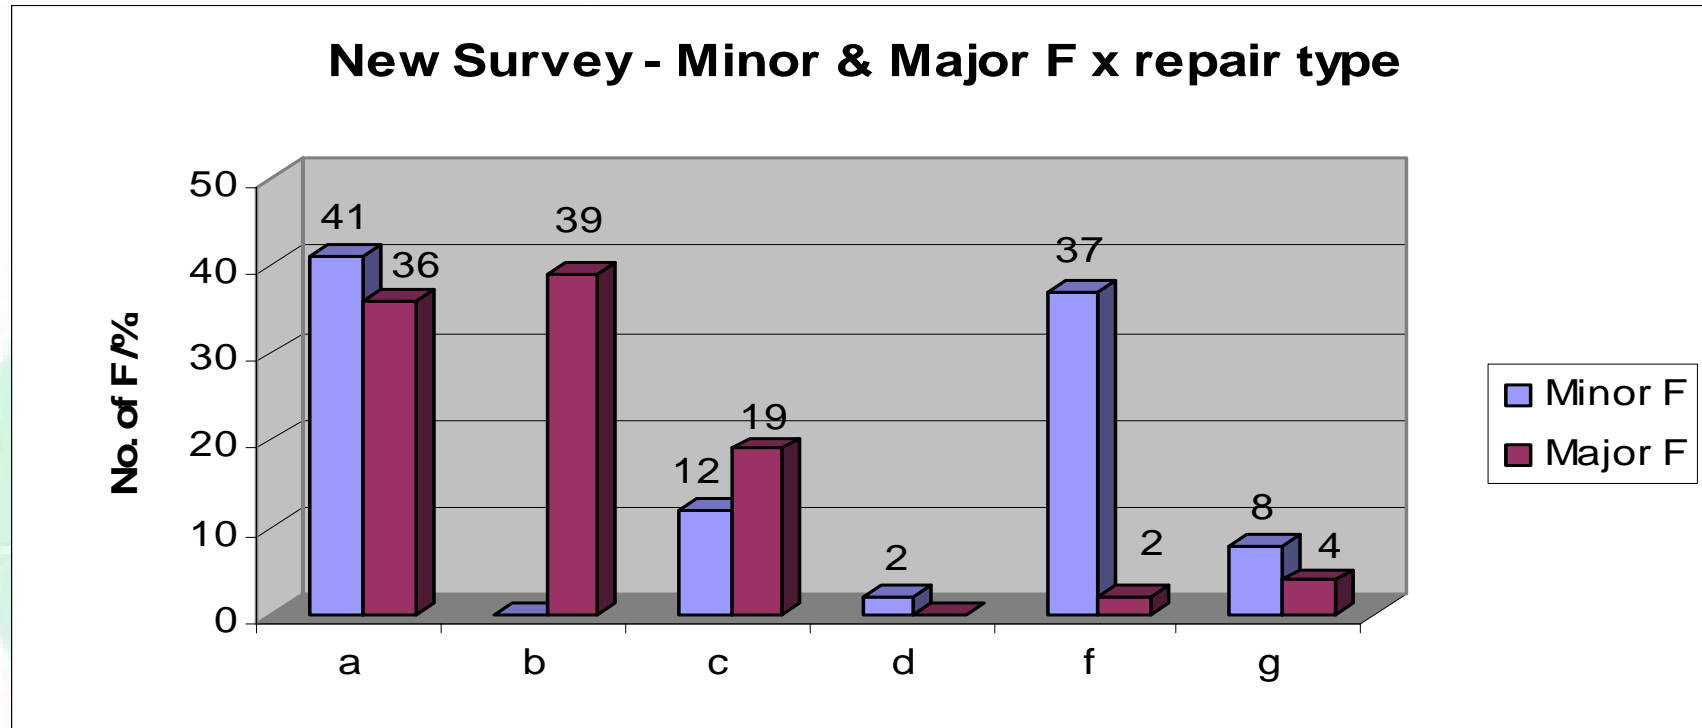
a - Repair of failed component on site

b - Repair in factory or shop

c - Replacement of failed component on site (without replacement of enclosure)

d - Replacement of failed component and its enclosure

f - Replacement of seals or refilling only

g - Placed back into service without repair
