## INTERMEDIATE RESULTS FROM ON-GOING CIGRÉ ENQUIRY ON RELIABILITY OF HIGH VOLTAGE EQUIPMENT

C.-E. SÖLVER\*, A. GIBOULET, W. GRIESHABER, D. KOPEJTKOVA, J.G.  
KRONE, D. MAKAREINIS, M. RUNDE, J.E. SKOG, on behalf of WG A3.06\*\*

*Abstract: CIGRÉ WG A3.06 is presently carrying out a worldwide enquiry of failures in service on high voltage equipment rated for voltages greater than or equal to 60 kV. The survey covers circuit breakers (only single pressure SF<sub>6</sub> technology), disconnecter switches, earthing switches, instrument transformers and GIS. The collection of information from utilities started in 2004 and will continue to the end of 2007. The paper presents intermediate equipment populations covered by the survey, and gives samples of major failure modes and causes. Preliminary trends, in relation to previous CIGRÉ surveys, are discussed.*

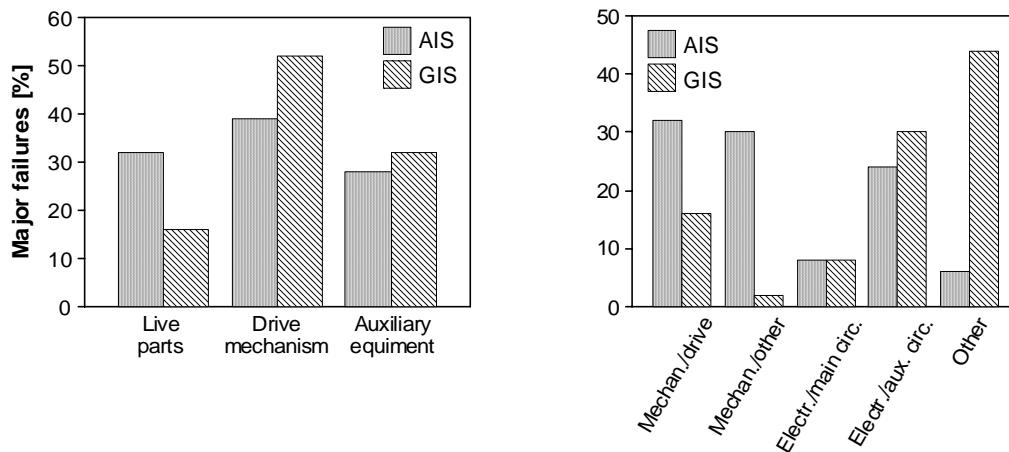
Fig. 4. Distribution of major failures between the different subcomponents of the disconnector / earthing switches (left) and grouped after failure cause (right).

Fig. 4 shows the major failures grouped by failed component and failure cause. The general finding for AIS is that the failures split about equally between live parts, drives and auxiliary equipment. For GIS the majority of the failures are associated with the operating mechanism.

Furthermore, mechanical failures account for the majority of the major failures in AIS. For GIS the majority of the failures are electrical and “Other” (presumably unknown) failure causes.
